THERMAL WAVE IMAGING OF AIRCRAFT STRUCTURES

L.D. Favro, T. Ahmed, Xiaoyan Han, Li Wang,
Xun Wang, Yingxia Wang, P.K. Kuo, and R.L. Thomas
Department of Physics and Institute for Manufacturing Research
Wayne State University, Detroit, MI 48202, USA

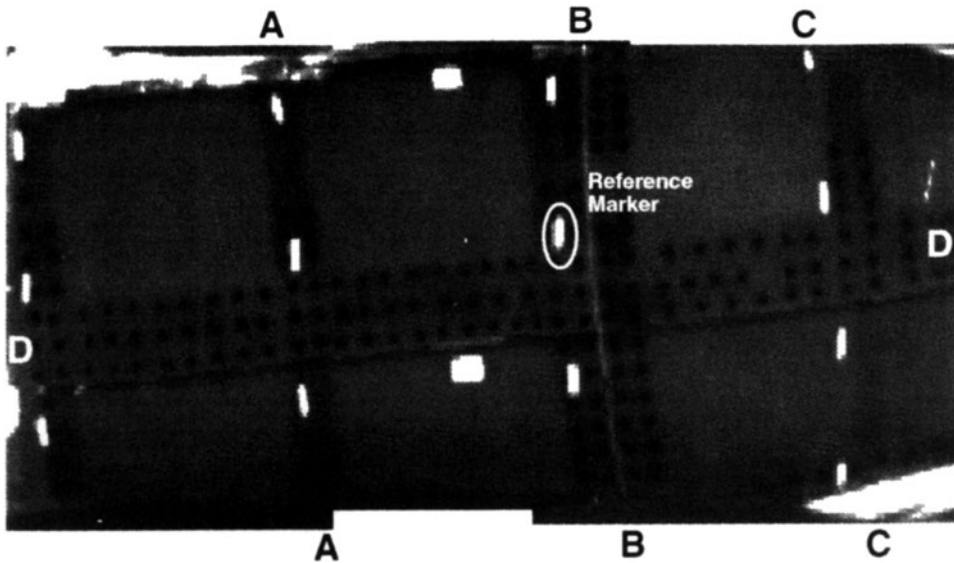
In Fig. 1 we show an example of a thermal wave image of a region of the FAA's B737 aircraft testbed, located in the FAA-AANC hangar at Albuquerque. This area, and other areas of the aircraft imaged in each of the following figures were first painted with a water soluble paint to improve the heat absorption and emission. The region imaged in Fig. 1 was chosen to be illustrative of one for which there is minimal subsurface corrosion and disbonding. Three images were overlapped to comprise Fig. 1, and each was taken using a delay time of 0.17 sec following the application of a spatially uniform, ~4 msec duration heat pulse on the surface of the aircraft.

Fig. 1 Example thermal wave image showing subsurface structure (e.g. bonded lapsplICE: D-D; a well-bonded tear strap; A-A, a butt joint; B-B, etc.). This image was taken using a delay time of 0.17 sec following the application of a spatially uniform, ~4 msec duration heat pulse on the surface of the aircraft. With the possible exception of a section of the tear strap C-C, no subsurface corrosion or disbonds are apparent in this image. The various white patches in the image are reference markers applied to the surface of the aircraft.

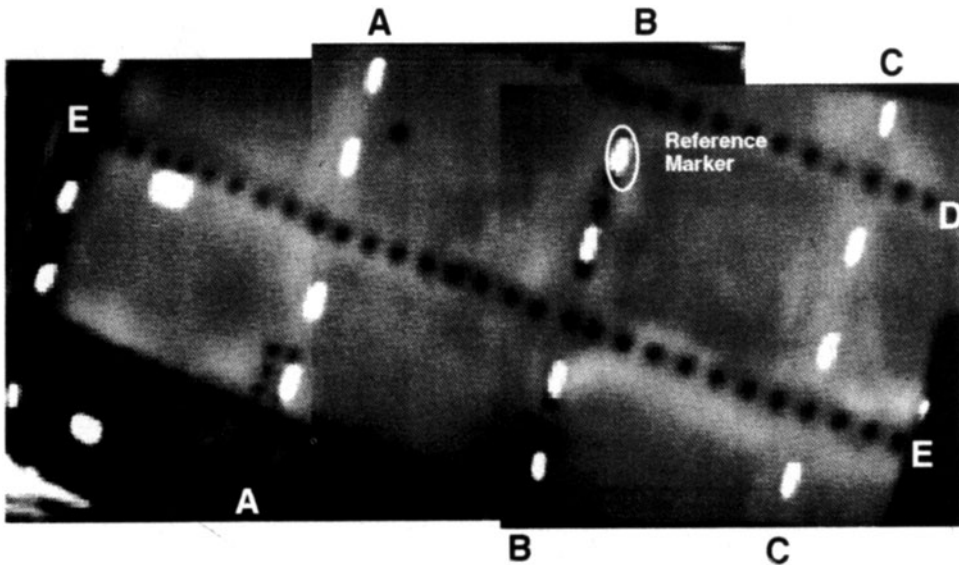
In contrast to Fig. 1, Fig. 2 is a thermal wave image of a region of the aircraft which contains verified subsurface defects. This image, also taken at a gate time of 0.17 sec, shows regions of corrosion and/or disbonding (e.g. the bright region along stringer E-E, to the right of frame station B-B and the "staircase-shaped" bright region to the left of B-B, above E-E). These defects have also been seen by ultrasonic imaging [2].

Fig. 2 Thermal wave image (also taken at a gate time of 0.17 sec) showing regions of corrosion and/or disbonding (e.g., the bright region along stringer E-E, to the right of frame station B-B, and the "staircase-shaped" bright region to the left of B-B, above E-E). These regions have also been seen by ultrasonic imaging [2]. The various white patches in the image are reference markers applied to the surface of the aircraft.

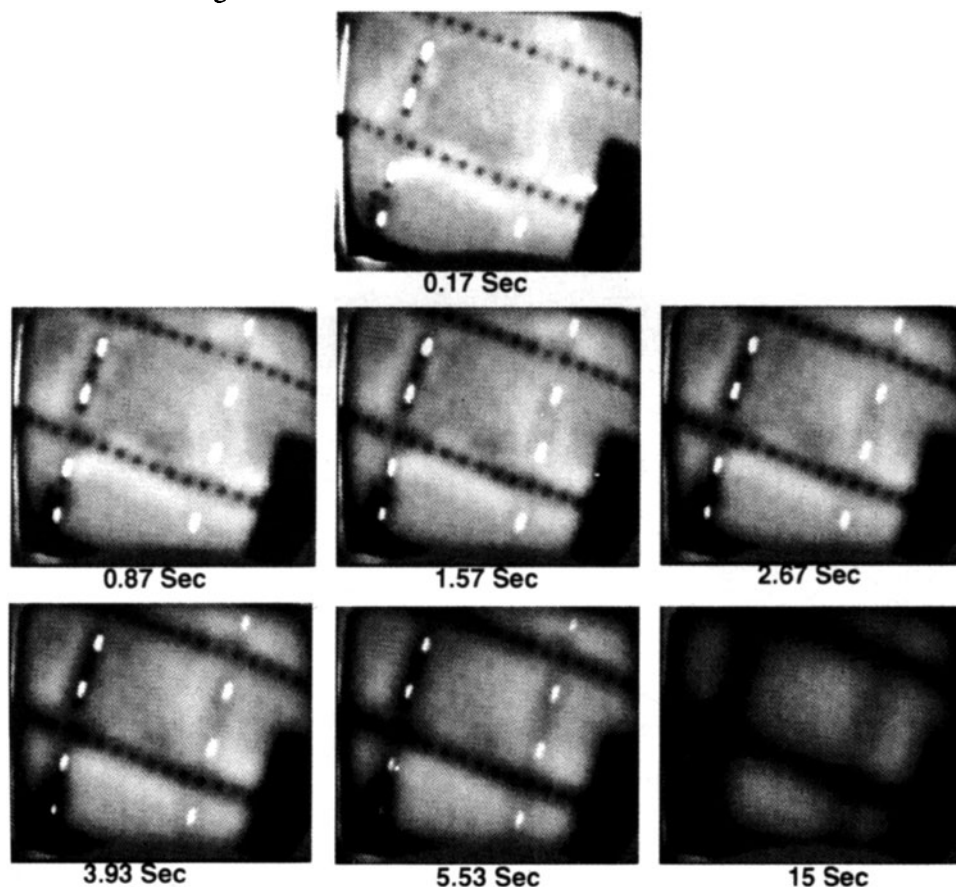
Figure 3 shows a series of thermal wave images taken at seven successively longer gate times following a single heat pulse. These images are shown to illustrate the ability of thermal waves to reveal increasingly deeper features as the time delay following the heat pulse increases. The top image repeats the experiment illustrated in Fig. 2, and the succeeding images show progressively deeper features beneath the surface. The bonded structures are only evident at the latest gate times, and the tear strap to the right side of these images (see also B-B in Fig. 2 above) appears not to be well bonded. It may also be noted that the images grow progressively more blurred as the delay gate time for the image is lengthened. This effect is the result of the lateral heat diffusion during the thermal wave propagation [3]. It has been shown [4] that it is possible to apply an inverse thermal wave scattering algorithm to greatly reduce the blurring of similar thermal wave images, and that the algorithm can be implemented in less than a minute on a personal computer.

Fig. 3 Series of thermal wave images taken at seven successively longer gate times following a single heat pulse. The top image repeats the experiment illustrated in Fig. 2, and the succeeding images show progressively deeper features beneath the surface. The bonded structures are only evident at the latest gate times, and the tear strap to the right side of these images (see also B-B in Fig. 2 above) appears not to be well bonded. The various white patches in the image are reference markers applied to the surface of the aircraft.

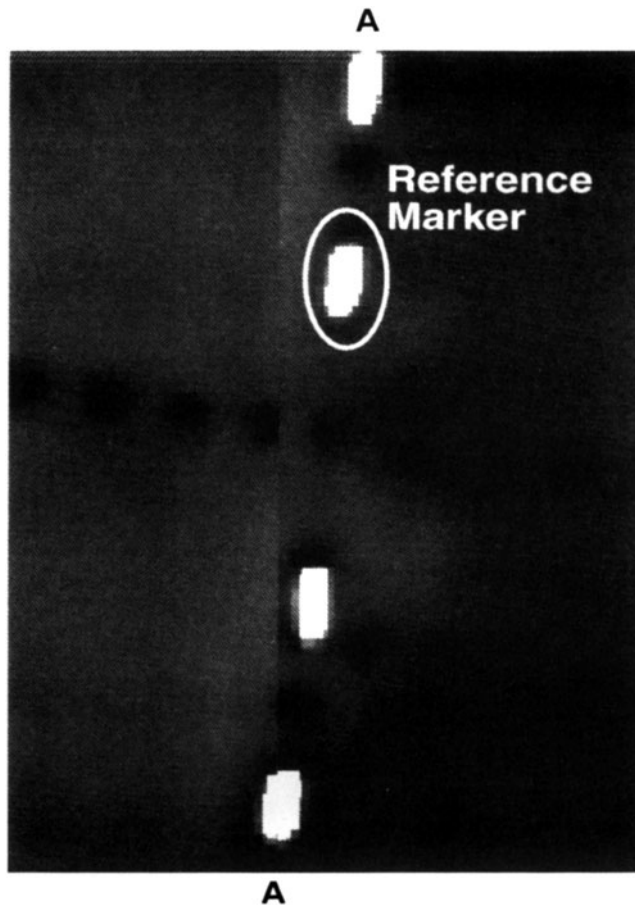
Figure 4 shows a thermal wave image taken in a region for which there is a bonded doubler beneath the outer skin of the fuselage. The bright regions of the thermal wave image indicate the presence of corrosion and/or disbonding of the doubler, which extends inward from the edge of the doubler.

Fig. 4 Thermal wave image (also taken at a gate time of 0.17 sec) showing a boundary A-A, to the right of which is an internal doubler beneath the skin of the fuselage. The irregularly shaped lighter regions to the right of A-A are indicative of corrosion and/or disbonding intruding from the edge of doubler. The various white patches in the image are reference markers applied to the surface of the aircraft.

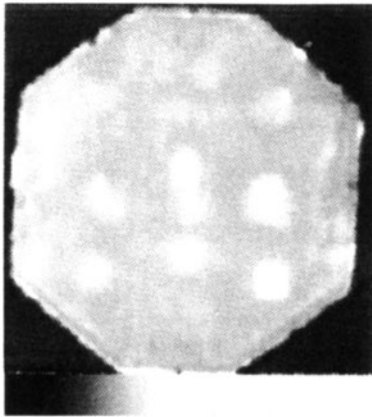
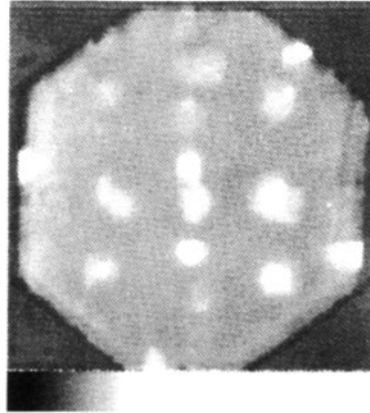
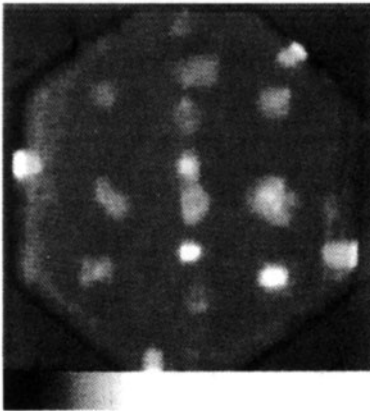
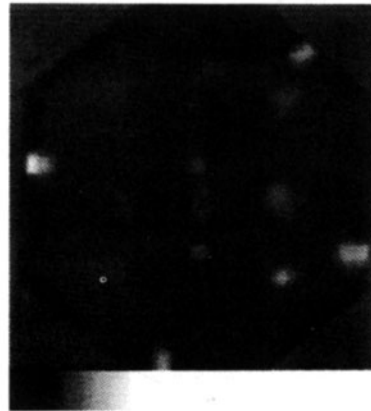
The FAA's B737 aircraft testbed also contains a region of fuselage on which has been applied a boron-epoxy composite patch reinforcement, such as is currently being utilized by the Air Force to reinforce weep holes areas in wing structures of C-141 aircraft. This particular patch was prepared with a number of artificial subsurface planar defects, and was applied in a region of the B737 located at the intersection of a stringer and frame station. Figure 5 presents thermal wave images of this composite patch, showing the thermal wave reflections from the artificial defects, from regions of weak bonding above some of the fasteners along the stringer, and (at later gate times) from the stringer and frame station beneath both the patch and the fuselage skin.

Fig. 5 Thermal wave images of a boron-epoxy composite patch on the B737 testbed, showing the thermal wave reflections from the artificial defects, from regions of weak bonding above some of the fasteners along the stringer, and (at later gate times) from the stringer and frame station beneath both the patch and the fuselage skin.
